Study and Restoration of the Zeyrek Camii in Istanbul: First Report, 1997–98

ROBERT OUSTERHOUT, ZEYNEP AHUNBAY, AND METIN AHUNBAY

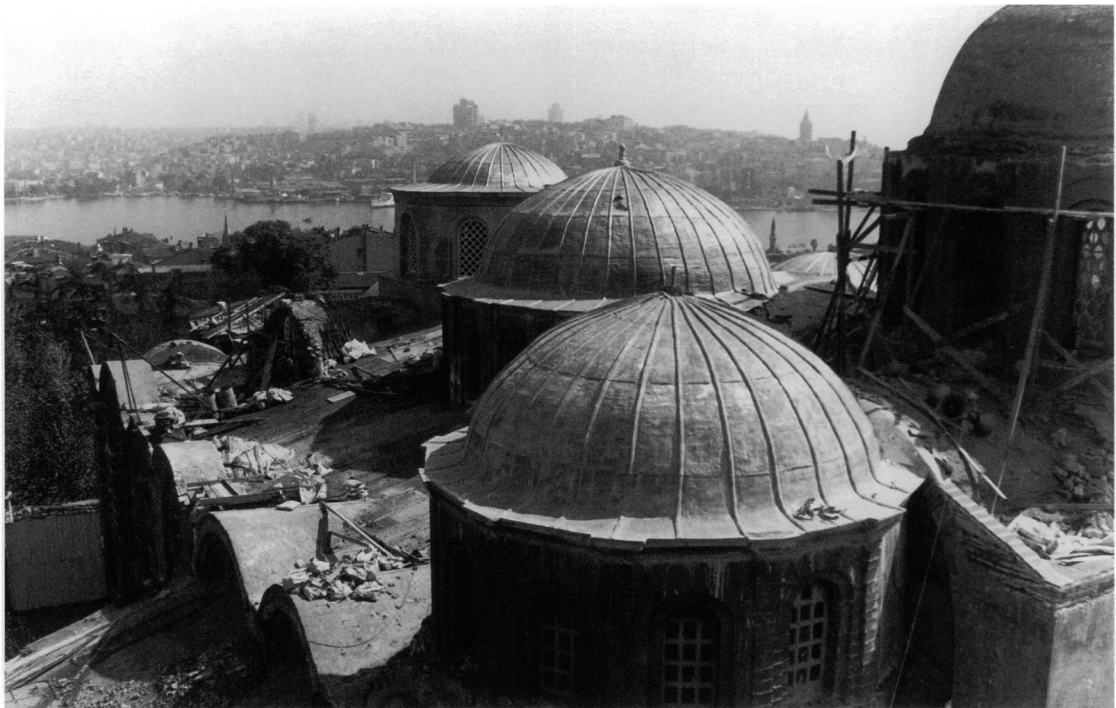
The modern roof level is considerably higher in places than the Byzantine roof, adding a steeper angle to the undulating forms of the original covering (Fig. 2). Although attractive, the complicated form of the Byzantine roof probably encouraged leakage, and a slope has been maintained in the new roof. The modern form of the roof was the result of interventions in the 1960s, but the steeper pitch was already present in the nineteenth century. This has left an attic level between the concrete roof and the vaulting along the west side of the building. In places, the pitched roof rises more than 1.40 meters above the Byzantine vaults. In this protected area, considerable information is preserved from the early history of the building.⁸

2 Zeyrek Camii, general view from the minaret, looking north, during the restoration, 1998

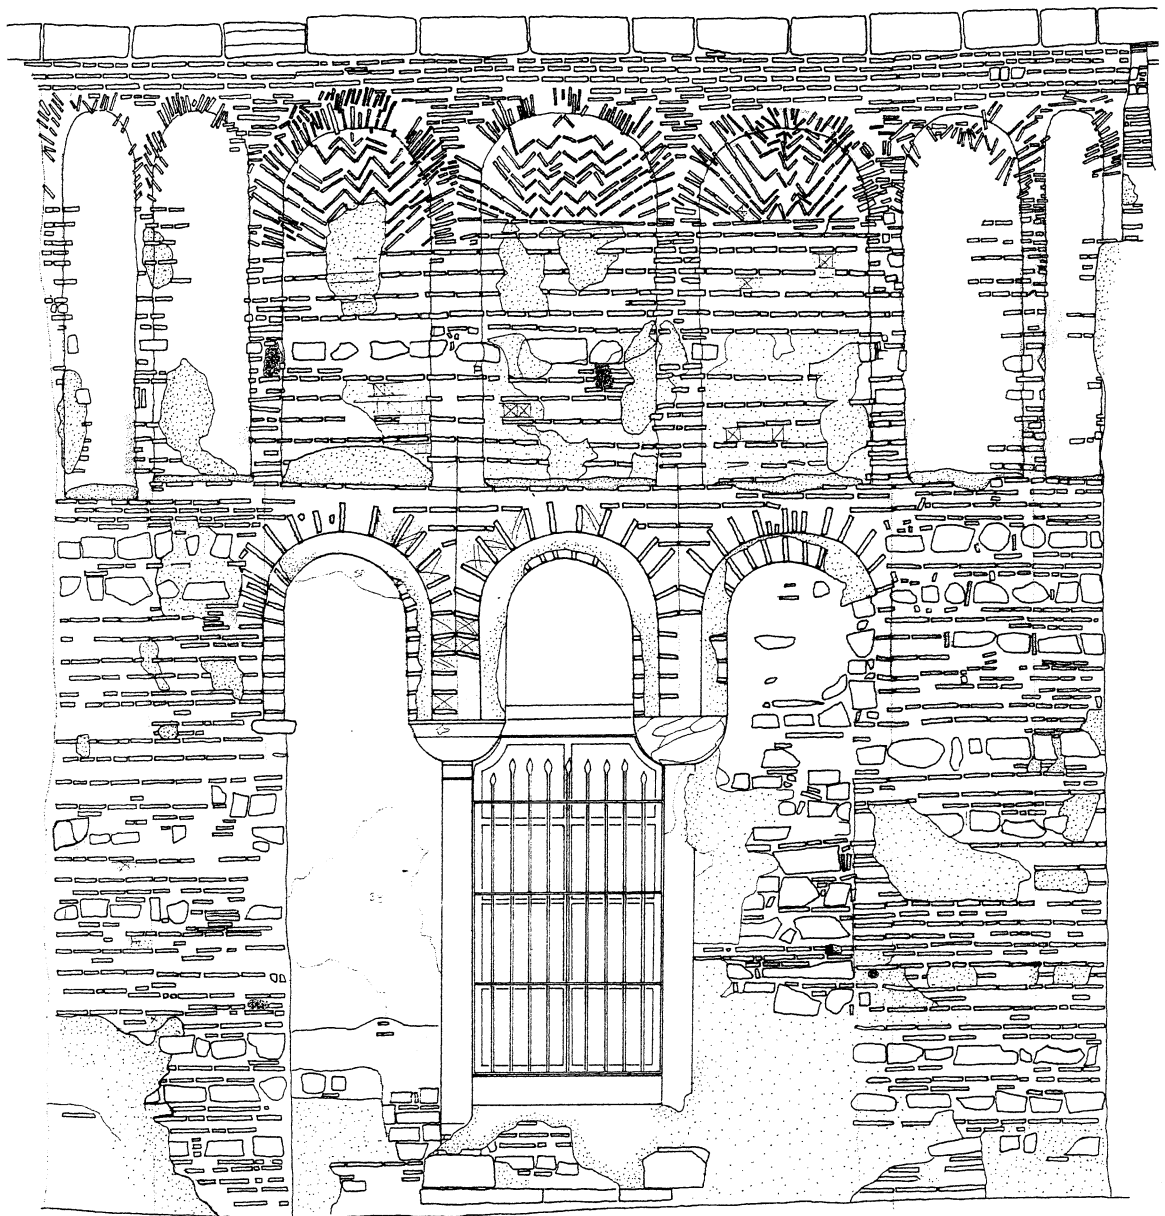
4 Zeyrek Camii, Middle Building, detailed elevation of east facade, 1998

The examination of the eastern facade of the Middle Building indicated that it had been repaired several times in the past (Fig. 4). At present the wall is damaged by the loss of bonding mortar at its joints and by the accumulation of soot. Some of the stone has also deteriorated. The capital of the north column is cracked, and its surface is eroded. Two of the apse windows are blocked, and the remaining one much reduced. During the work in this area, the damage was recorded, and a tentative proposal for the restoration was developed. To implement the project, we needed the analysis of mortars and plasters from this surface, as well as expert advice for cleaning the brick, limestone, and marble. Specialists from the Ministry of Culture's Central Laboratory for Conservation and Restoration are now addressing these problems.

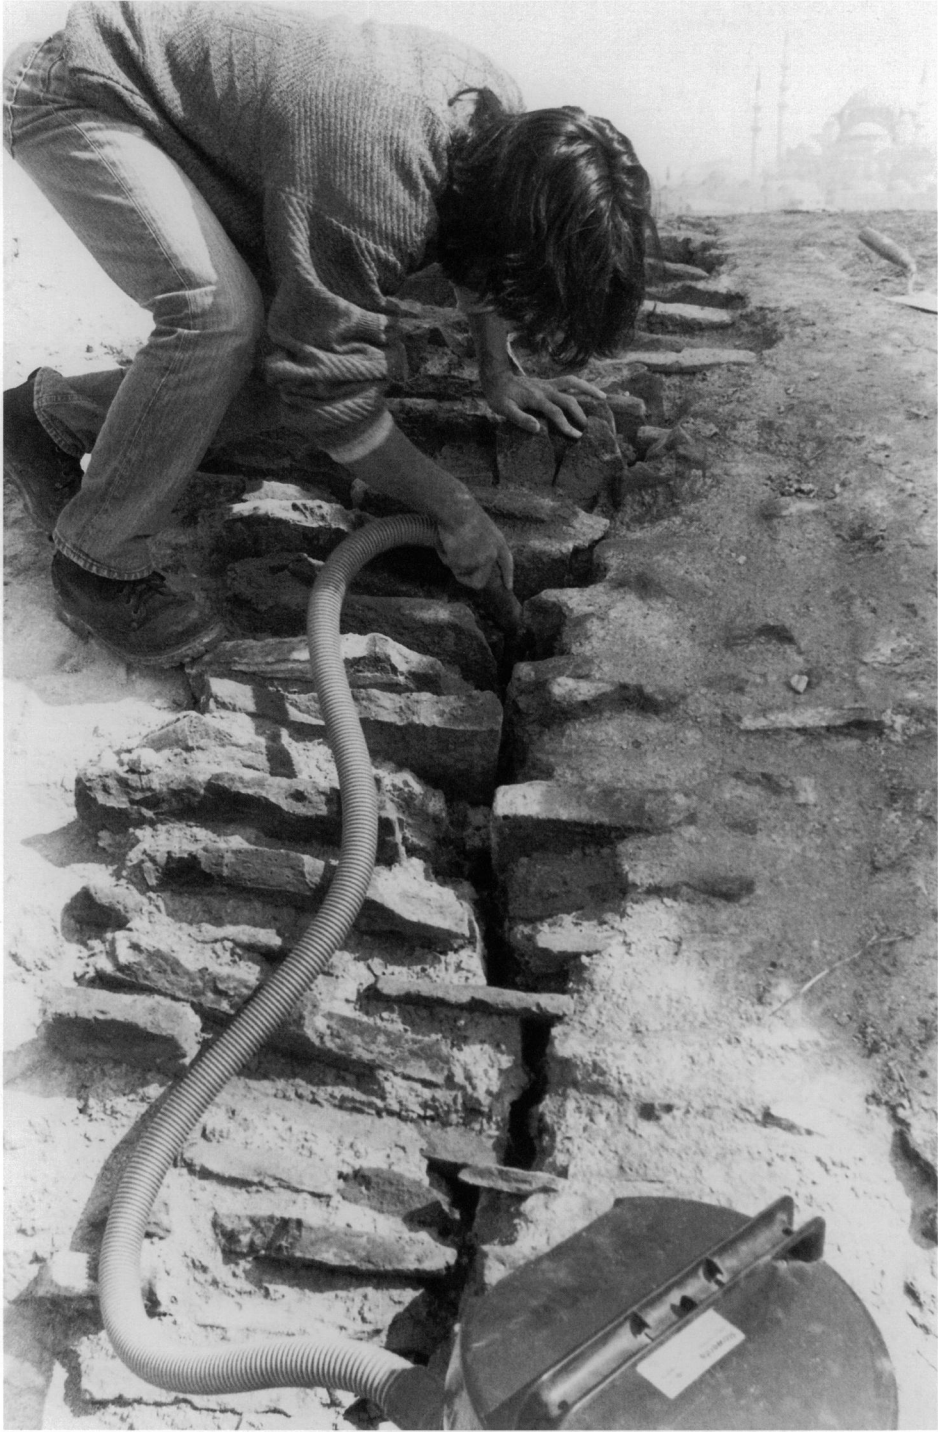
7 Zeyrek Camii, North Building, cleaning of crack in north crossarm, 1998

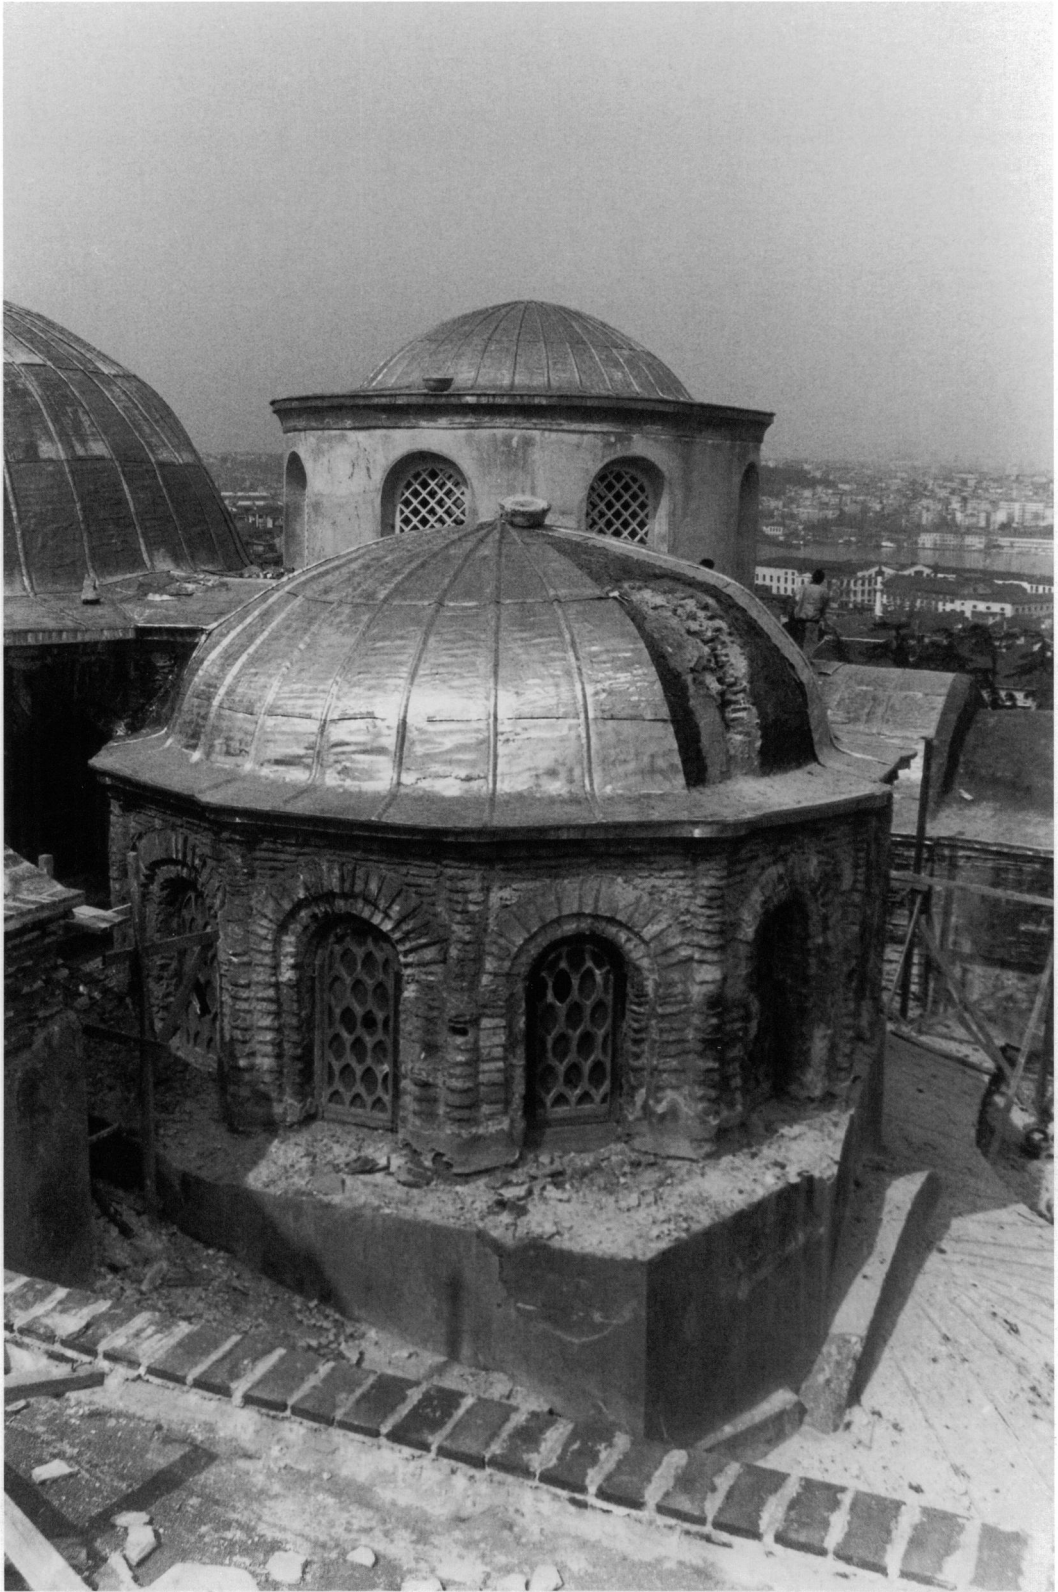
8 Zeyrek Camii, view from South Building, looking north, showing roofing in progress and eastern dome of Middle Building during repair, 1998

Eight cracks at the base of the western dome of the South Building and one major crack over the eastern dome of the Middle Building (Fig. 8) were similarly treated. A crack running parallel to the north wall of the North Building became visible after the fill over the prothesis was removed. It had been previously stitched with lime mortar, and stone blocks had been placed over the crack. The old mortar had disintegrated, so the fracture was cleaned to a depth of 22 centimeters and filled with the repair mortar.

After the cleaning, repair, repointing, and replastering of the vaults and domes, a layer of mud plaster was spread over the finished surface, and lead sheeting 2 millimeters thick was fixed into place with nails (Fig. 8). Following traditional practices, the mud plaster provides a protective cushion beneath the lead roofing. In places where it was necessary to raise the roofline, ceramic sherds were used as fill material. As of August 1998, approximately 50 metric tons of lead had been applied, with an additional 10 metric tons necessary to complete the roof work. However, the roofing system over the western part of the building will require further study before it can be replaced (Fig. 2). The raised, reinforced concrete roof was added here in 1967, and a proposal must be presented to the Monuments Council before it can be removed. The modern brick columns and reinforced roof slabs exert concentrated loads onto the historic structure and may cause damage to it.

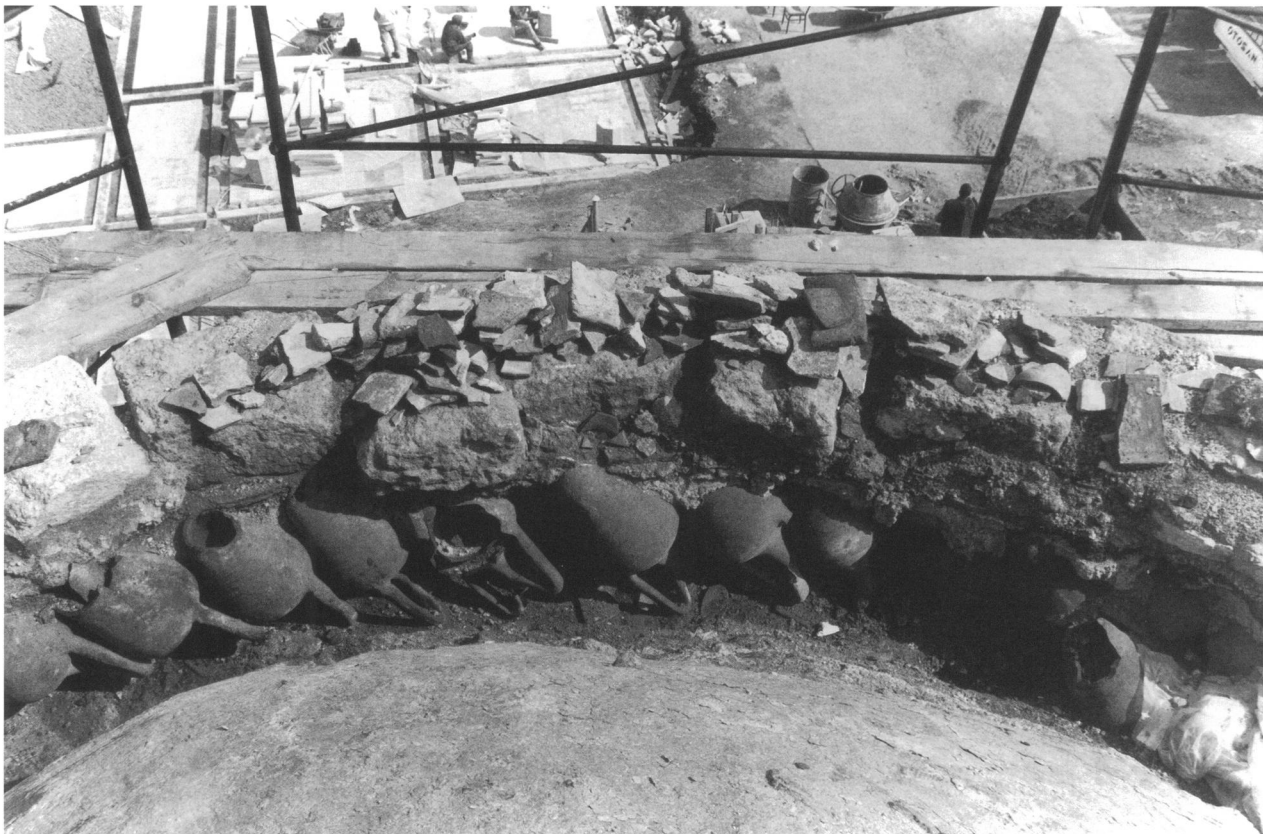
9 Zeyrek Camii, North Building, view toward the apse vault during cleaning, showing Byzantine amphorae in the fill behind the conch and Ottoman cornice blocks joined with iron ties, 1997

During the removal of the old roofing materials from the apse of the North Building, we encountered a packing of Byzantine amphorae embedded in ash and charcoal (Fig. 9). These had been employed during the original construction to fill the void between the apse semi-dome and the eastern wall.⁹ A similar practice was observed in the eastern vault of the South Building. In addition, many large fragments of

This packing of amphorae on the North Building was carefully excavated by archaeologist Aysin Özügül, whose report appears as an appendix to this study. Nineteen amphorae were removed, studied, and restored; they have now been deposited in the Museum of the Vakıflar in Istanbul. They were replaced by similar ceramic vessels of modern production before this area of the roof was recovered.
