The Monastery of St. Chrysostomos at Koutsovendis (Cyprus) and Its Wall Paintings Part I: Description

CYRIL MANGO

Our publication will be in two parts. Part I contains a description of architecture, sculpture, and

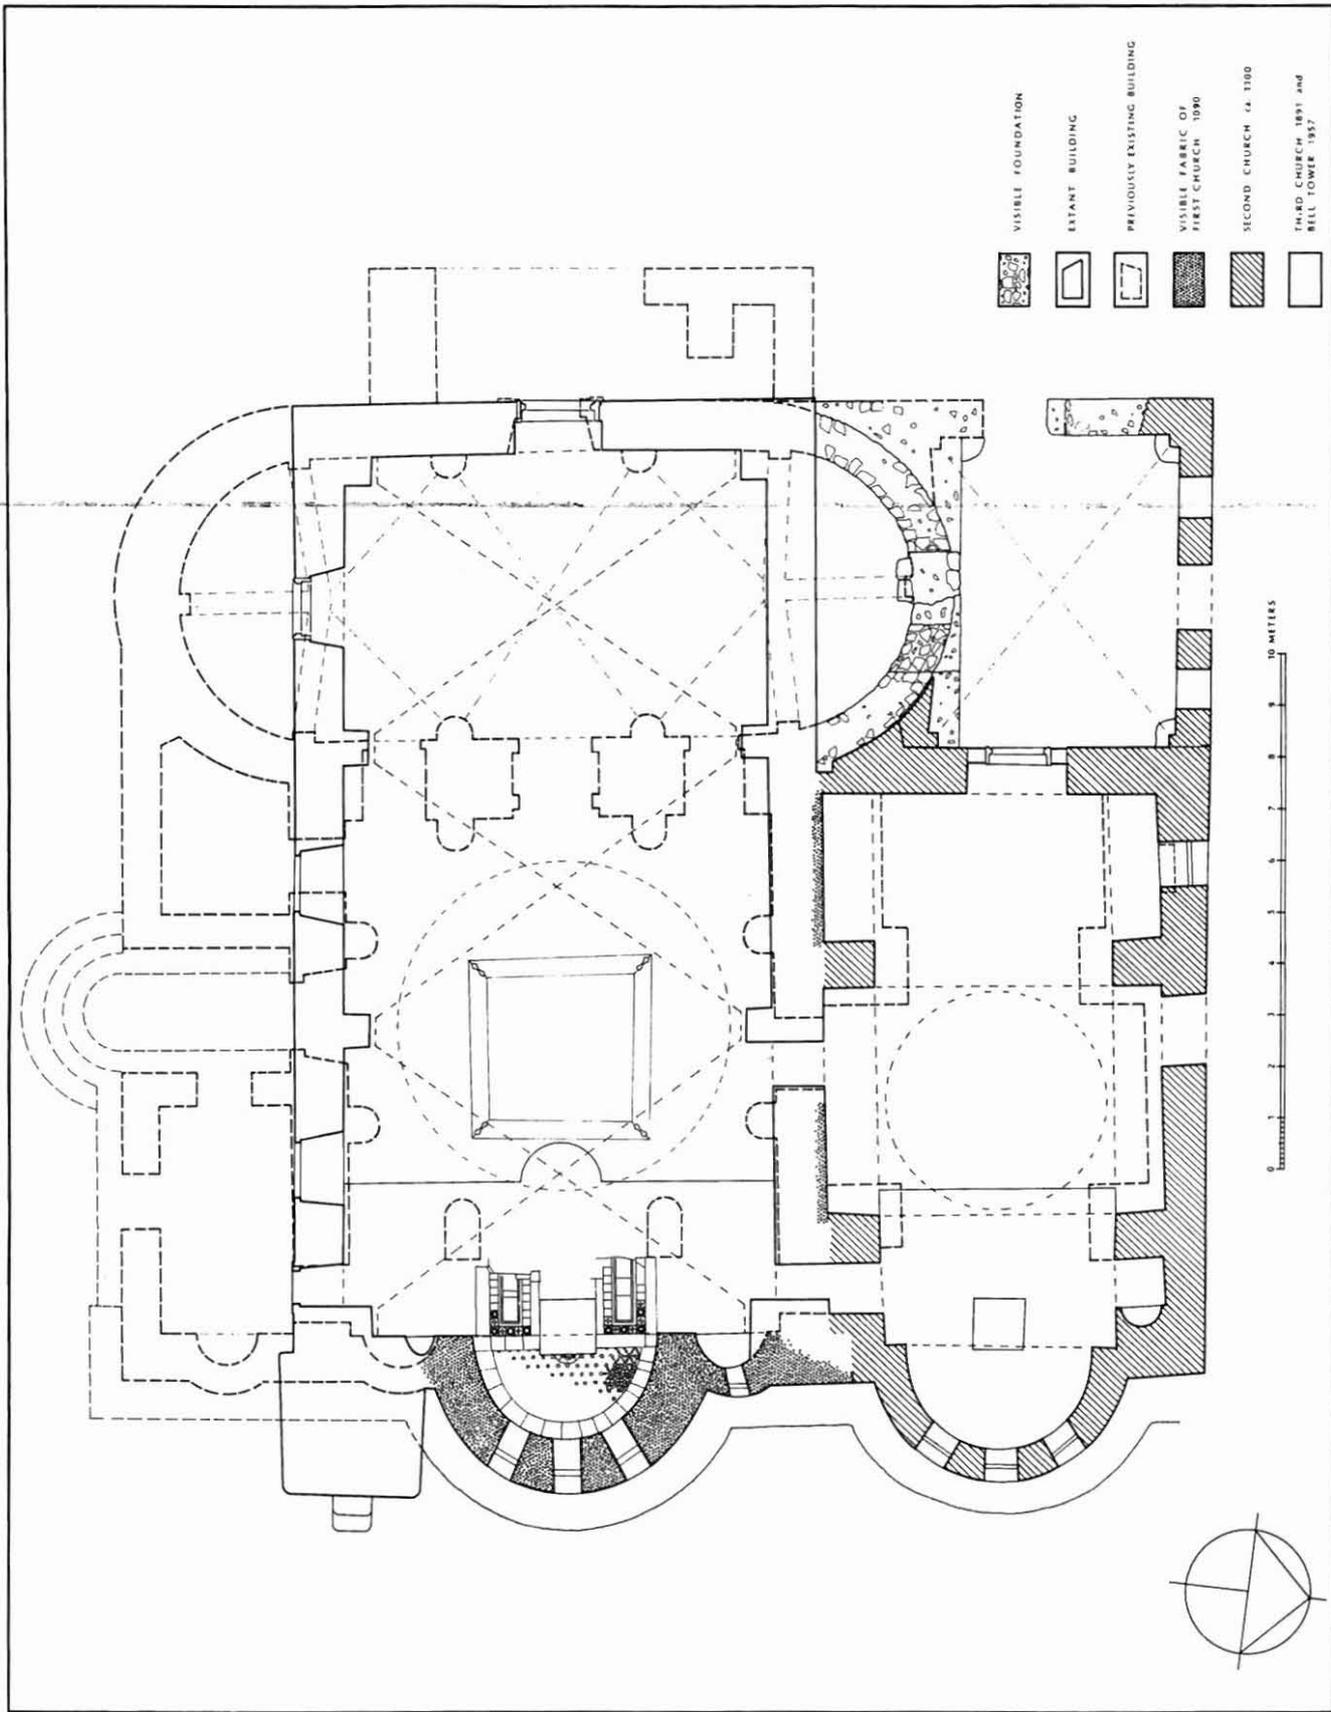
6 Ground plan of the two churches (drawing: Richard Anderson)

Equal in length to the south church, but appreciably narrower, the north church is a specimen of what may be termed the "compressed cross-in-square type." While its plan is sufficiently regular, the west door is noticeably off axis. This is due to the projection of the preexisting north apse of the narthex of the south church. For the same reason the narthex of the north church was built in an asymmetrical form (Fig. 6).

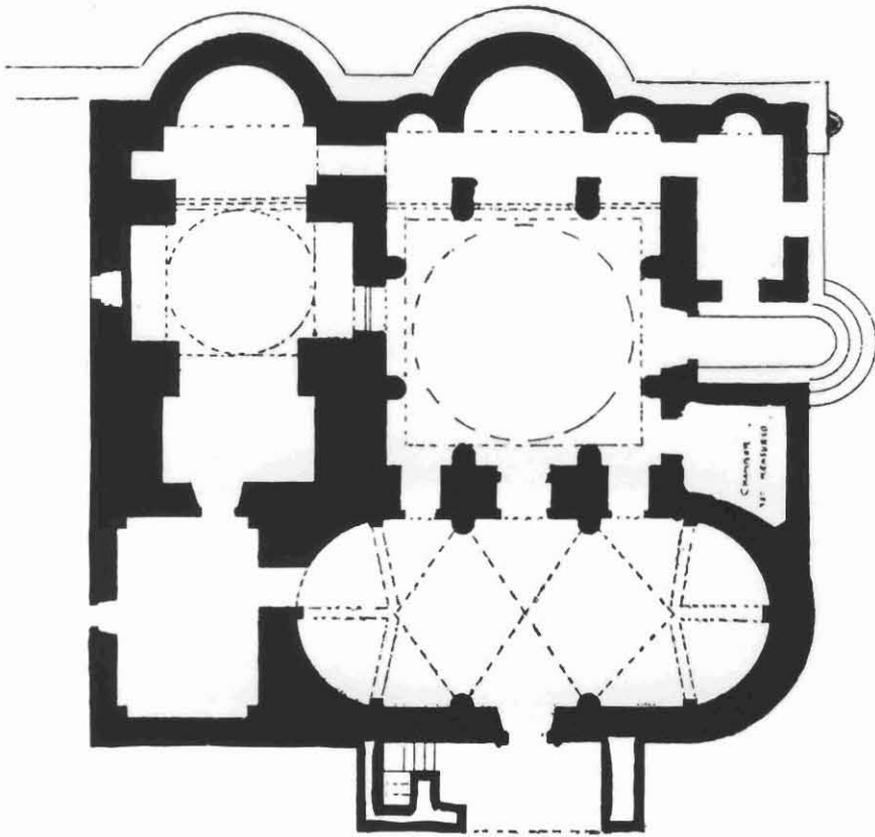
7 Ground plan of the two churches, before 1891 (after W. Williams)

Our knowledge of the original south church is in large measure due to a plan made some time before 1891 by W. Williams, district engineer of Cyprus, and published by G. Jeffery (Fig. 7).²⁵ It

shows a rectangular nave very nearly 10 m from east to west and about 8 m from north to south (internal measurements), covered by a dome about 6.30 m in diameter. The dome was supported on eight rounded piers, the two eastern ones being freestanding and the rest engaged in the walls. It may be observed that the space between the eastern piers was slightly narrower than the opening of the central apse, so that the arches linking the piers to the apse must have diverged toward the east, a peculiarity that is also observable in the roofless church of St. Hilarion's castle.²⁶

Communicating with the nave by three doors was a deep narthex, terminating in semicircular apses to north and south. The wall of the south apse is shown abnormally thick by Williams, possibly as the result of the addition of a skin of masonry on the outside. The vaulting of the narthex had clearly been altered in the Gothic period, as also happened in the Apsinthiotissa monastery.²⁷ Examination of the extant portion of the north apse shows that it originally had an axial door, 1.40 m wide. On its west jamb were observed two renderings of painted plaster, the earlier one having a black horizontal line on a yellow background at a height of 35 cm above the original floor level, while the later one was green. The door was filled in connection with the insertion of a Gothic rib, and another door, 1.25 m wide, was cut through the wall immediately to the east of the rib (Fig. 9). The north apse stands on a rectangular platform, which appears to be original.

The Williams plan shows two subsidiary structures attached to the south wall of the church, namely, a small chapel with an apse and some sort of chamber (not measured on the inside), with an open passage between the two, terminating in a semicircular flight of three steps. There was also a porch, containing a staircase, built against the west wall of the narthex.²⁸

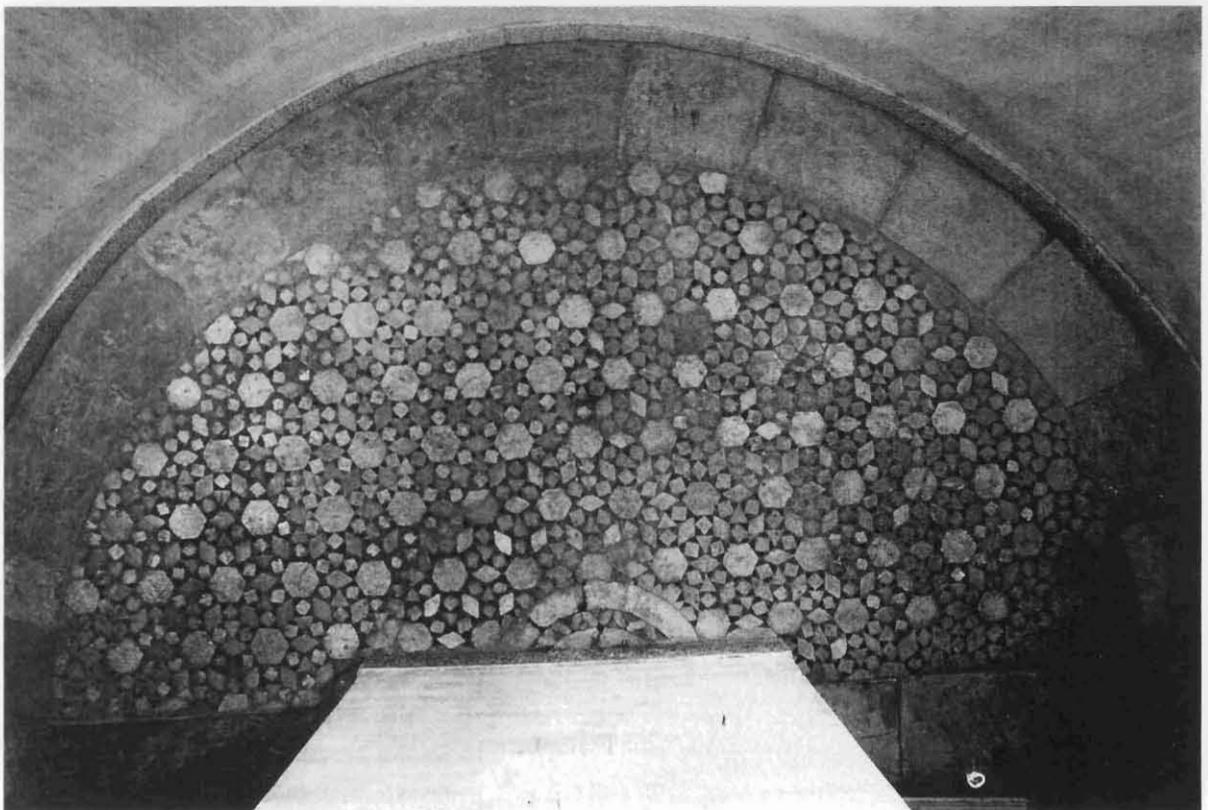
10 South church, opus sectile pavement of central apse

The semicircle of the central apse is covered with an over-all pattern in opus sectile consisting of little hexagonal plaques joined at their corners by diamonds (Fig. 10). This was repaired and reset by the Department of Antiquities while our work was in progress. To the north and south of the modern altar table is an incomplete rectangular panel of pink marble within a double border of opus sectile (Figs. 11, 12). The large square frame in the middle of the nave also appears to be original. It is of white Proconnesian marble with figure-8 corner insets in verd antique. The paving within the frame, including a small section of opus sectile (Fig. 14), probably taken from elsewhere, is, however, modern. A comparable square frame in the contemporary church of Veljusa in Yugoslav Macedonia is filled with interlace.²⁹

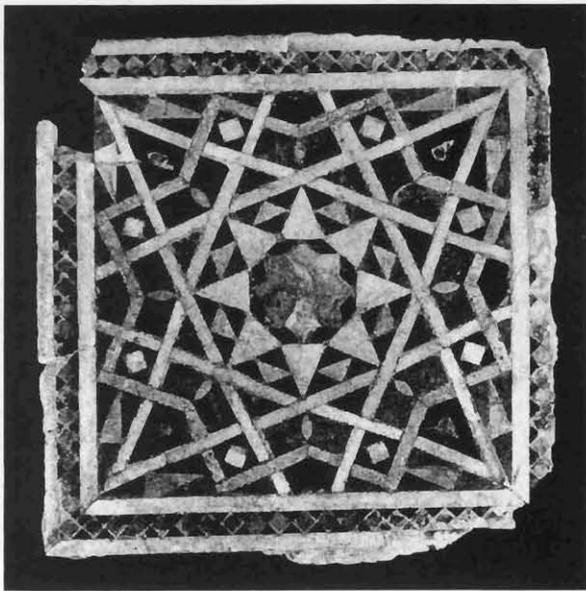
13 Loose panel of opus sectile

We saw, furthermore, a loose fragment of opus sectile, 44 cm square (Fig. 13), decorated with an intricate pattern based on eight-pointed stars. It is made of white, gray, black, and yellow marble, red stone, and one small piece of green porphyry.

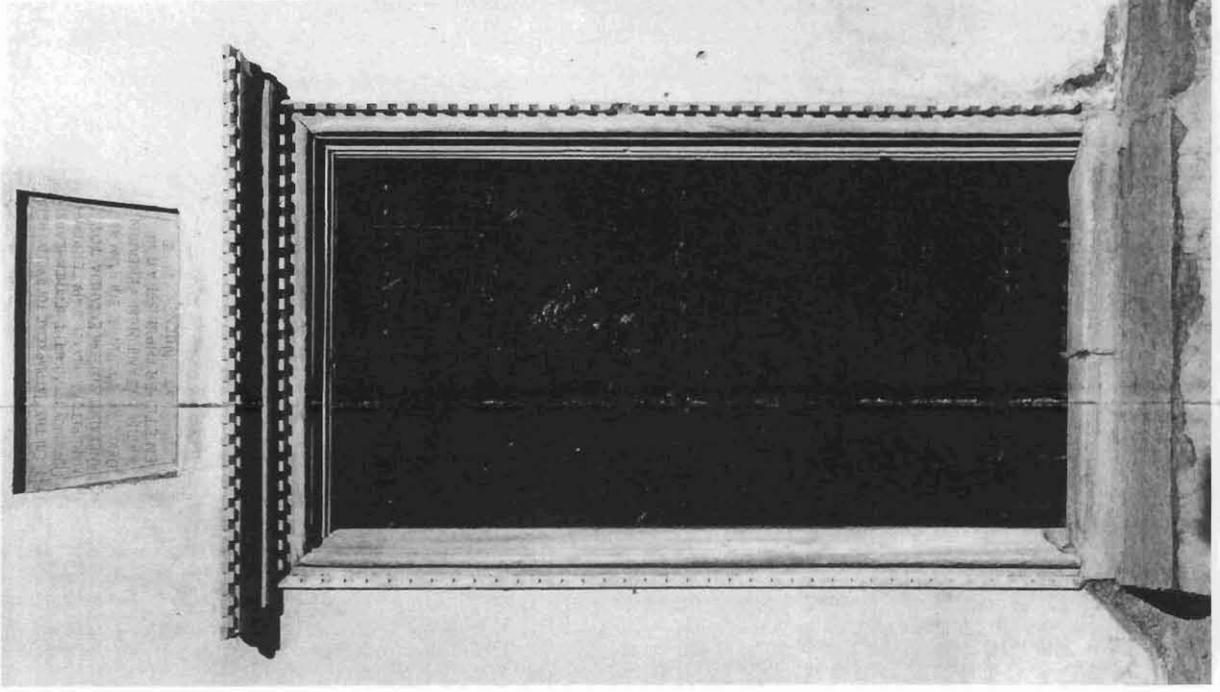
16 South church, southwest door

The original south church, which constituted the *katholikon* of the monastery, was for the most part demolished and rebuilt in 1891, as stated in the following inscription placed over its southwest door (Fig. 16)

Three door frames of Proconnesian marble are preserved, being inserted: (1) in the west door of the south church (Fig. 15); (2) the southwest door of the same (Fig. 16); and (3) the west door of the north church (Fig. 17). None is in its original position, and No. 3 was only put to its present use when the west wall of the north church was restored by the Department of Antiquities in 1947. As noted above (p. 65), Barskij claims to have seen six door surrounds, whereas Pococke and von Richter mention only three, namely, those pertaining to the three doors that led from the narthex into the nave. It is highly likely that those are the three surrounds that have survived. The biggest frame, No. 1, measures 2.66 × 1.57 m (outside dimensions, including edging of dentils) and has an opening of 2.50 × 1.25 m. The corresponding dimensions for No. 2 are 2.06 × 1.24 and 1.93 × 0.96; and for No. 3, 2.06 × 1.25 and 1.94 × 0.97. Nos. 2 and 3, which form a matching pair, are surmounted by a splayed lintel decorated at the top with a double row of dentils that would be at home in a Byzantine monument of the eleventh

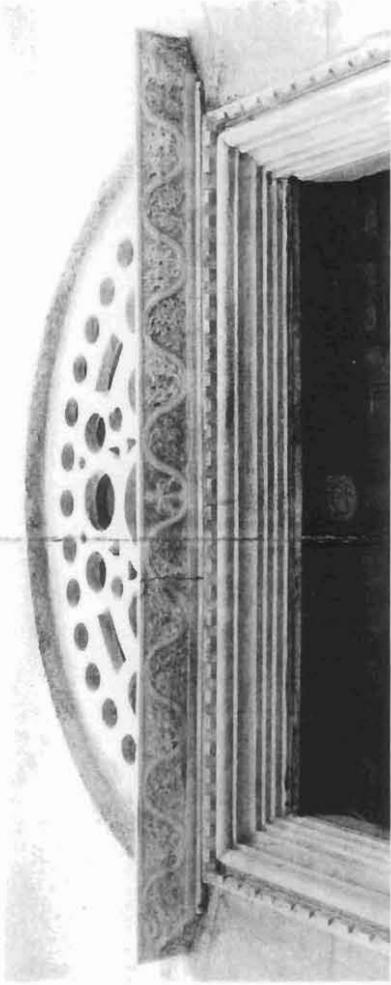
18 South church, lintel of west door

century.³⁰ No. 1 has a more elaborately decorated lintel (Fig. 18) with a twisting vine stem issuing from two small amphoras placed at the corners. The central twist of the stem encloses a "leaved cross" and each of the others contains a leaf with prominent veins and a bunch of pointed grapes. Although the motif is of Early Christian origin, the rather finicky carving does not appear to us Byzantine and resembles that of the two strange capitals which are now in the templon of the north church (Fig. 41). Whether this is Crusader work or later is a question we must leave open for the present.

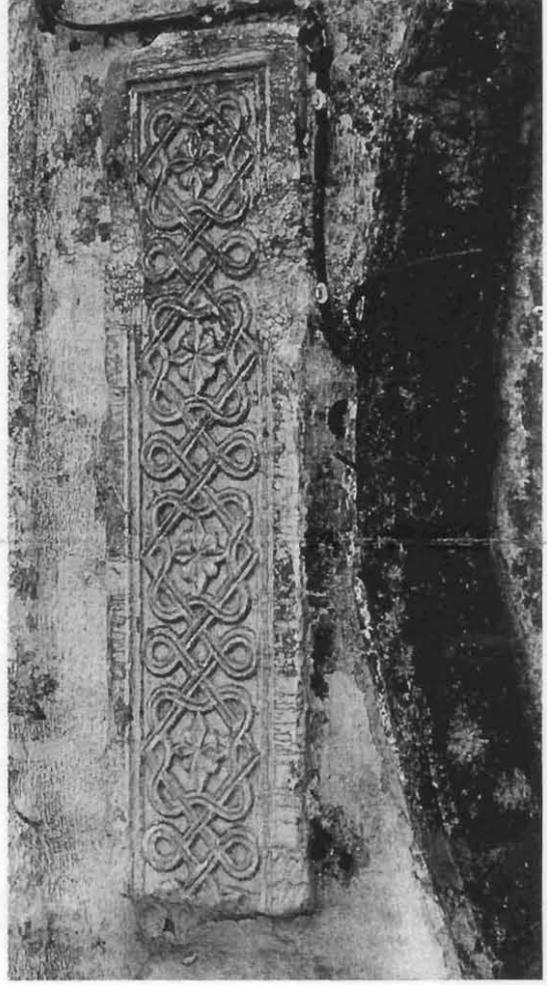
19 Fragment of sculpture above monastery gate

Among various fragments of stone preserved in the monastery was a broken parapet slab, 0.83 m high (Fig. 46). When complete, it would have been very nearly 1.00 m wide. It is only 3.5 cm thick, but appears to have been re-cut on the back and used, perhaps, as a table top. The decoration on the front is of an Early Christian type, consisting of a medallion, from the bottom of which issues a twisted rope, its ends terminating in an ivy leaf(?). Inside the medallion is a six-pointed star, while a three-petaled leaf is placed diagonally in the upper right-hand corner of the panel. In view of the dimensions of the slab, it may have been part of a chancel screen. Another fragment—a marble beam decorated with interlace—is immured above the entrance gate of the monastery (Fig. 19).

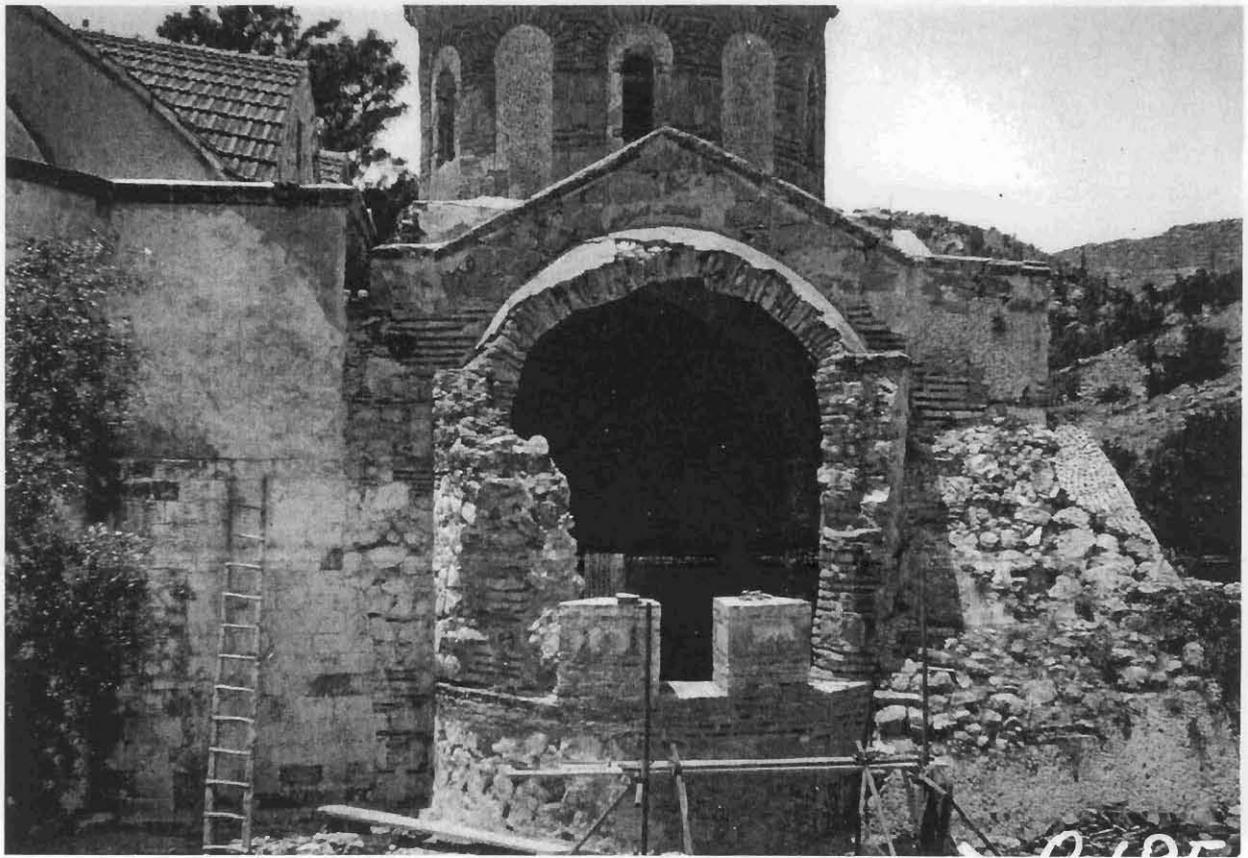
30 Apse in the course of rebuilding (1942) (photo: Department of Antiquities, Cyprus)

The first repairs, in 1942, consisted in the rebuilding of the apse (Fig. 30). In 1947 the west facade was restored (Fig. 32). This involved the insertion in the door opening of one of the marble frames from the south church and, above it, of a perforated gypsum grille, replacing the brickwork fill under the arch (possibly original), which was found to be in a precarious state. An intrusive rectangular window under the west gable was also filled up.

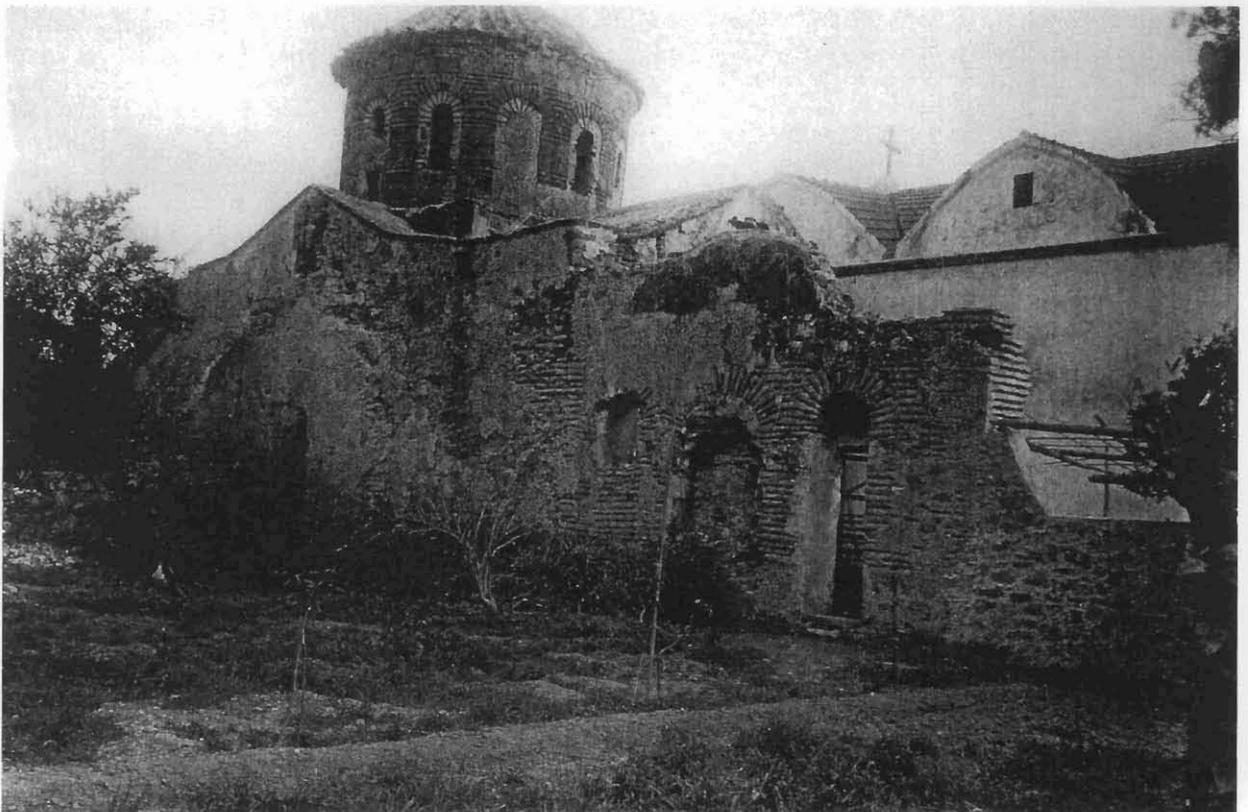
31 North facade before restoration (photo: Department of Antiquities, Cyprus)

During its long history the north church underwent a number of changes that are, unfortunately, all but undocumented. At an unknown date a major effort was made to reinforce the whole fabric by thickening the four main piers and underpinning the arches by an inner ring of masonry. The two western recesses (including the window of the north recess) were simultaneously filled up, as were some, if not all, of the dome windows and, possibly, the north door. Perhaps at the same time the roof line of the vaults, which form a cross at the base of the dome (assuming it was originally rounded, as it has since been restored), was altered to a gabled shape. This operation was carried out with some care, seeing that the east gable (Fig. 30) was constructed of fairly well cut blocks of stone, and a stringcourse, also of stone, was carried all round the building (except on its unexposed south side), defining the east, north, and west gables. Finally, an exterior buttress (since removed) was built against the east end of the north wall (Fig. 31).

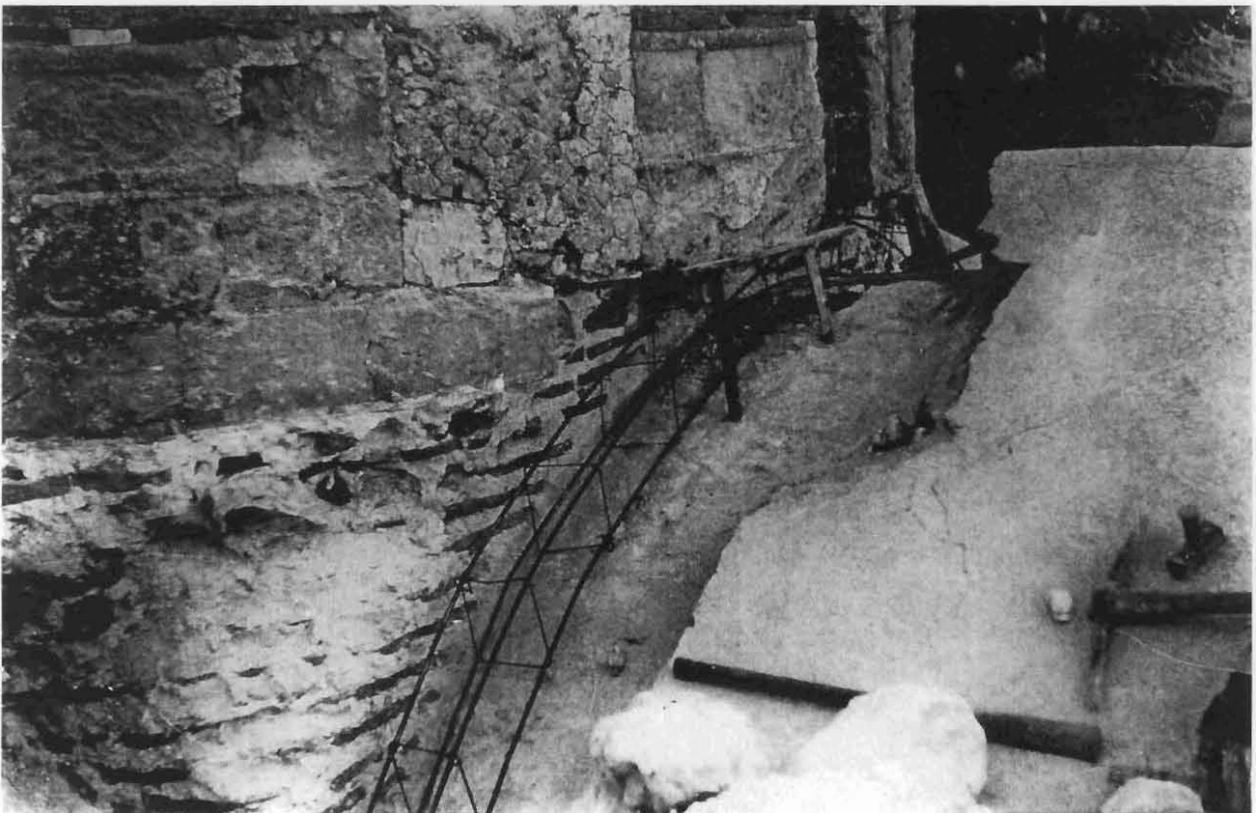
33 Insertion of reinforced concrete collar over bema vault (photo: Department of Antiquities, Cyprus)

The general repair of the church was completed in 1956–58.³² A concealed collar of reinforced concrete was carried round the whole building, with crossties east and west of the dome base (Fig. 33). A similar collar was inserted at cornice level of the dome. The structure having thus been made secure, the interior reinforcements, which we have attributed to the Lusignan or Venetian period, were removed, revealing such wall paintings as survive. The blocked dome windows were opened, as was also the original north door. The exterior buttress was dismantled. The masonry was made good, and all parts of the roof, including the dome, were retiled. In 1963 a new floor was laid in the church, and the marble columns of the iconostasis were set up,³³ though probably not in their correct position.³⁴ Finally, in 1970 parts of the walls were plastered to afford better protection to the paintings.³⁵

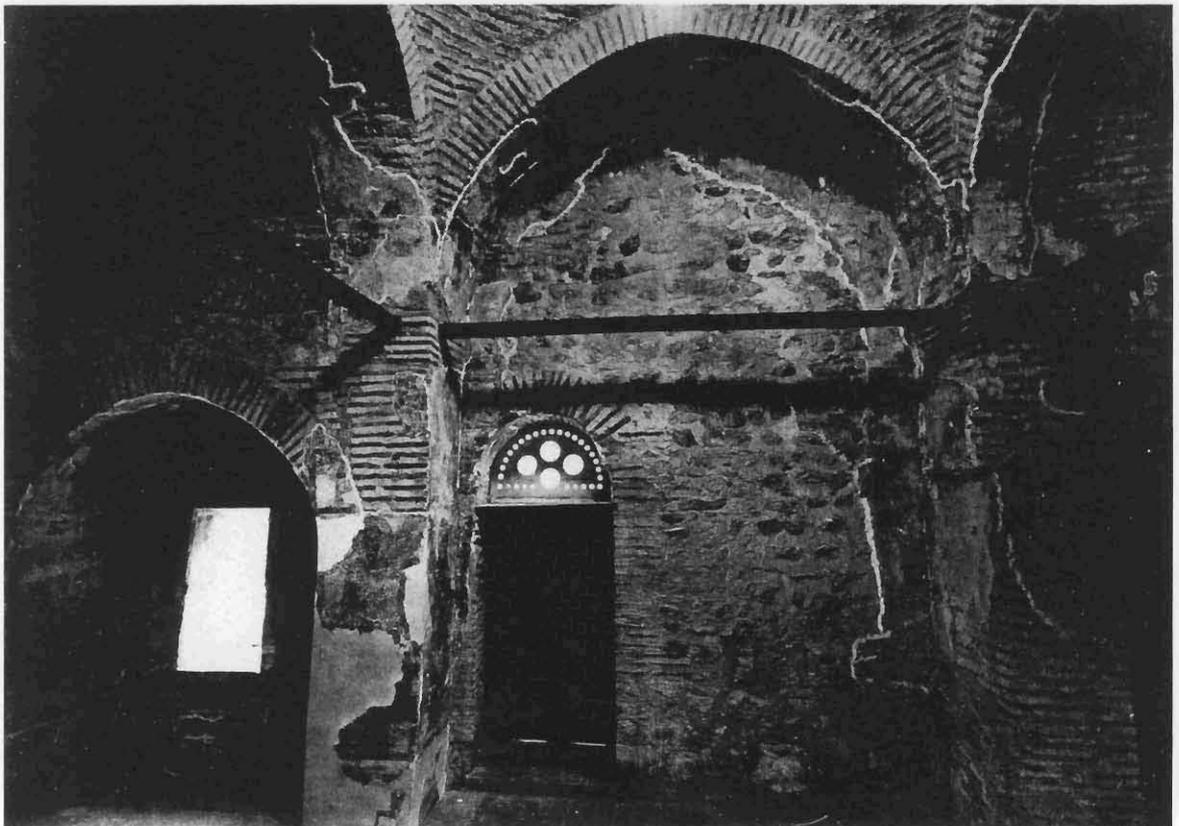
37 Interior looking north (1963)

Nearly the entire surface of the wall that is not covered with fresco is made up of rough rubble construction that cannot be original and looks, in fact, rather recent (Fig. 37). The primary brick construction is visible at the bottom of the wall, underneath the fragment of the Crucifixion, and, on the west side, near the springing of the arch. One can only conclude that at some time the greater part of the wall was broken through and later filled. One may further note that the Williams plan (Fig. 7) shows a fairly wide, filled door in the center of the wall and Soteriou's plan of 1933 likewise a central door, though somewhat narrower.³⁶ As to the present door, it is certainly original, though it may have been a few centimeters narrower than it is now; its east jamb is a modern restoration.
