Study and Restoration of the Zeyrek Camii in Istanbul: First Report, 1997–98

ROBERT OUSTERHOUT, ZEYNEP AHUNBAY, AND METIN AHUNBAY

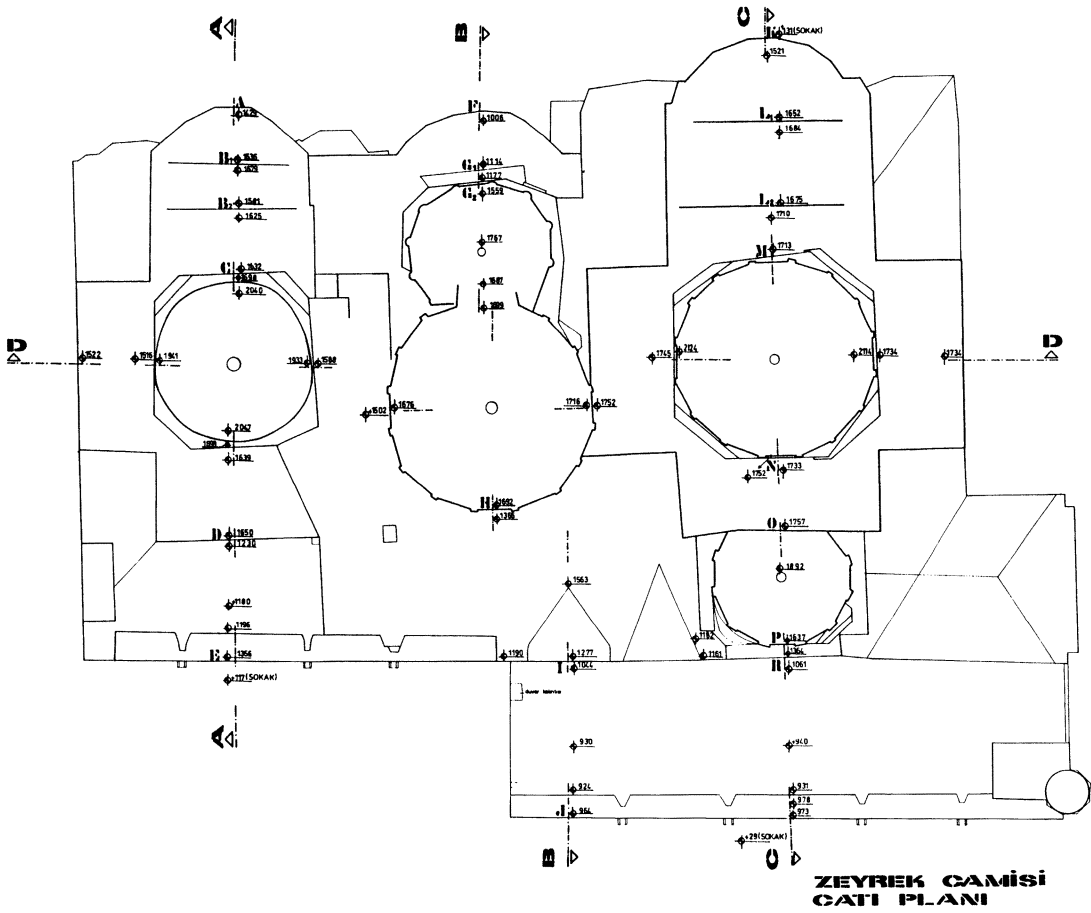
The modern roof level is considerably higher in places than the Byzantine roof, adding a steeper angle to the undulating forms of the original covering (Fig. 2). Although attractive, the complicated form of the Byzantine roof probably encouraged leakage, and a slope has been maintained in the new roof. The modern form of the roof was the result of interventions in the 1960s, but the steeper pitch was already present in the nineteenth century. This has left an attic level between the concrete roof and the vaulting along the west side of the building. In places, the pitched roof rises more than 1.40 meters above the Byzantine vaults. In this protected area, considerable information is preserved from the early history of the building.⁸

5 Zeyrek Camii, the complex plan of at roof level, prior to restoration, 1997

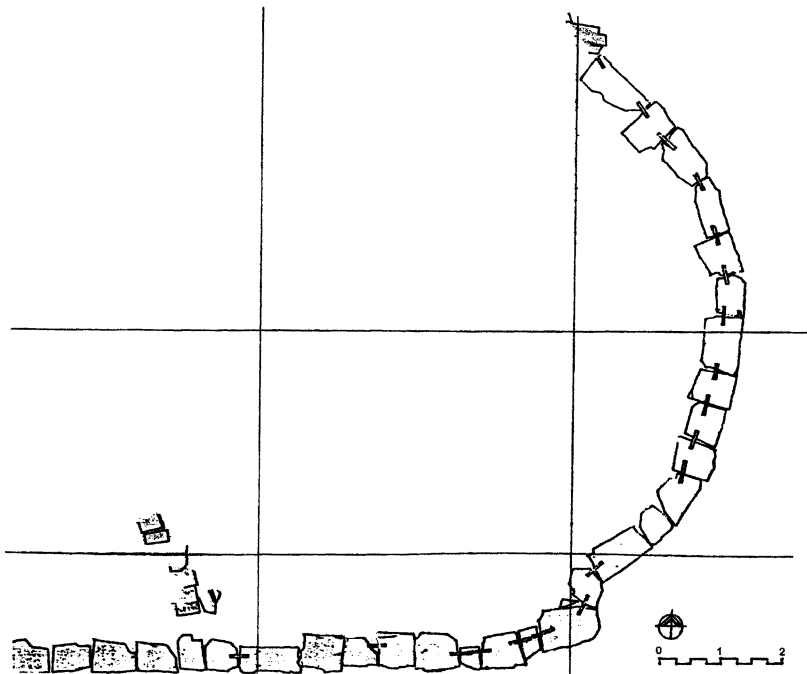
Work on the roof commenced with the removal of the concrete along the eaves, so that the historical cornices could be studied. Three different types of cornices were observed, and all have been preserved in the restoration. The Byzantine scalloped eaves of the domes were altered in the Ottoman period and replaced by a horizontal cavetto cornice of plaster laid over projecting courses of brick. The eastern cornices of the apses, extending onto the cross-arms, are also Ottoman in date; they are made of greenstone and have a chamfered profile. The individual blocks were fixed together with iron ties set in lead (Fig. 6). The surfaces of the greenstone cornices have been severely damaged. Although brick dogtooth cornices were

6 Zeyrek Camii, South Building, detailed drawing of cornice blocks, 1997

During an earlier repair, probably in the eighteenth century, the roof level was changed, with greenstone cornice blocks placed above the amphorae on the north apse. Most of the greenstone blocks of the eastern elevation had been broken, and their surfaces had deteriorated. These required *in situ* repair, facilitated by a mortar mixture that included an aggregate of the same stone, prepared by Dr. Ersen. Greenstone from the same quarry was acquired and crushed into particles no larger than 4 millimeters in diameter. The aggregate was then mixed with white cement and epoxy resin to create the repair mortar. Stainless steel rods were secured onto the cornice blocks, and a wooden formwork was constructed around them, into which the mortar mix was poured and allowed to dry. In a later stage, the profile of the cornice will be recarved.

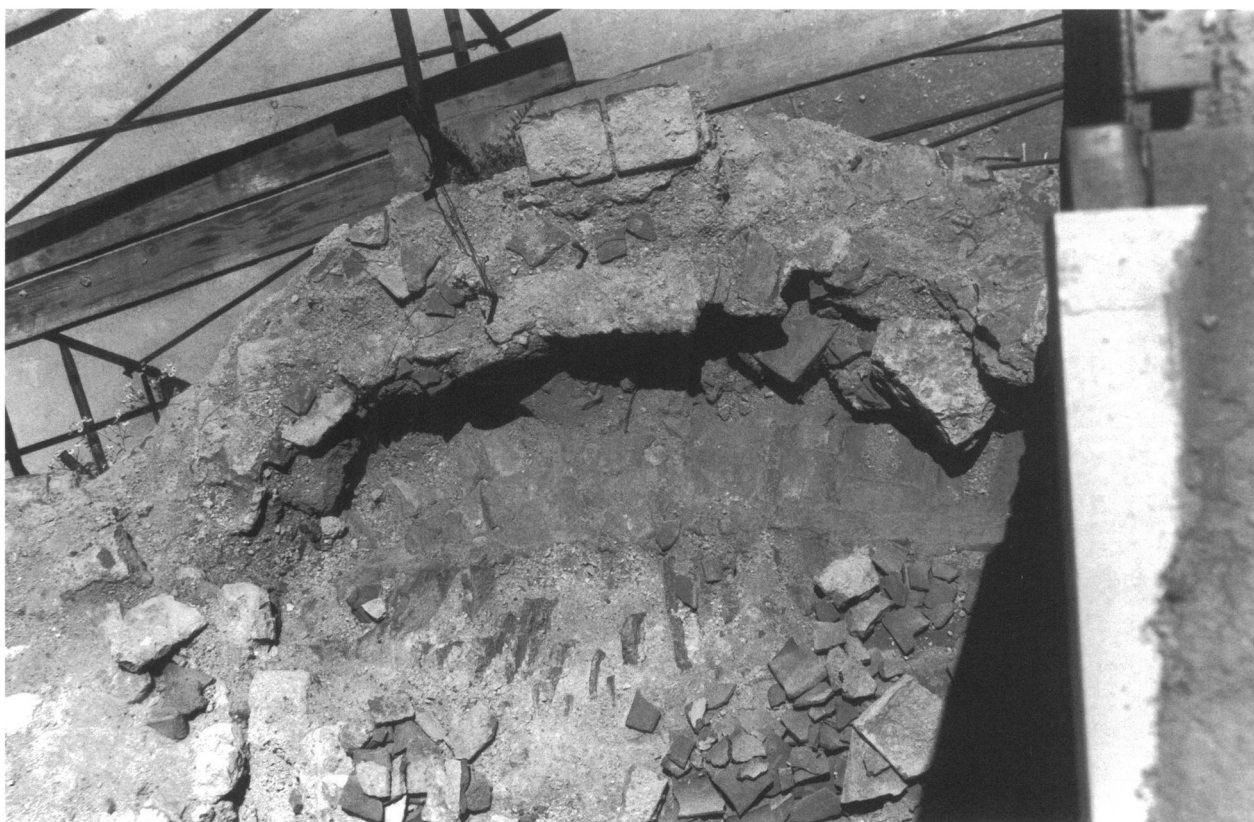
10 Zeyrek Camii, North Building, vaulting of the prothesis, showing Byzantine roofing tiles above the conch, 1998
