Excavations at the Cathedral of Haghia Sophia, Andravida, Greece

Author(s): Carl D. Sheppard

Source: Gesta, Vol. 25, No. 1, Essays in Honor of Whitney Snow Stoddard (1986), pp. 139-144

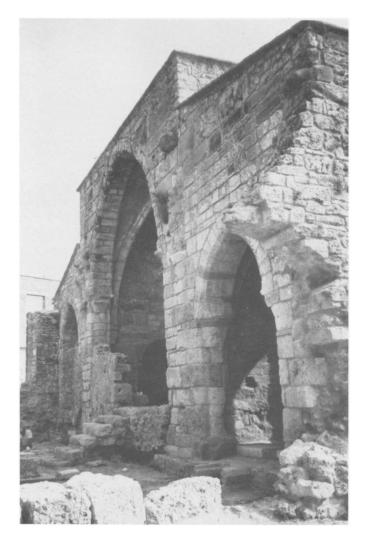
FIGURE 1. Cathedral of Haghia Sophia, Andravida, sanctuary from the west (photo: Ann Zelle).

rib-vaulted east end of the building still stands. In the early 13th century, during the reign of Prince Geoffrey I (1210-ca.1226), the original east end was probably unvaulted. Sufficient of the north and south walls survives to postulate a rather fortress-like appearance. The condition of the ruins suggests that vaulting was inserted at a later date, most probably during the rule of William II before he was made a prisoner in 1259. At some time during the

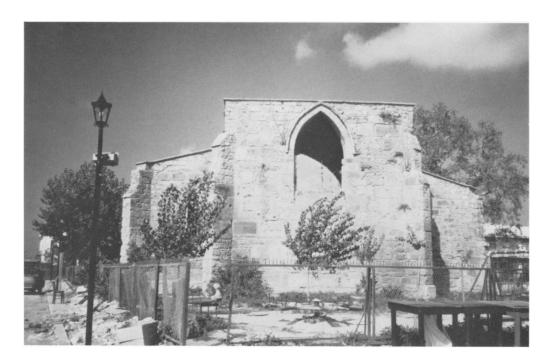
FIGURE 2. Cathedral of Haghia Sophia, Andravida, sanctuary from the south (photo: Ann Zelle).

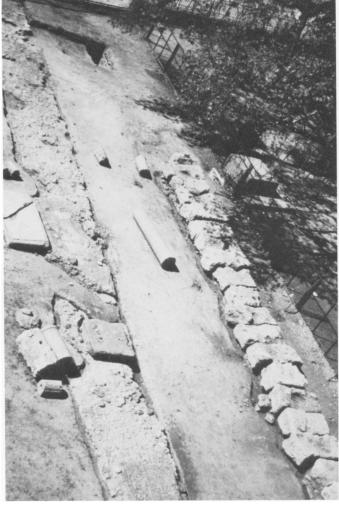
FIGURE 5. Cathedral of Haghia Sophia, Andravida, north pier wall foundations and line of north exterior wall (photo: M.-A.P.)

The attention of the Minnesota-Andravida Project during 1984 was concentrated on the west of the church. Three pier positions are now evident on the north colonnade which rested on a continuous rubble and cement foundation. The south colonnade does not rest on a continuous foundation but instead on irregular pourings of fine cement for each pier, which consisted of a classical sandstone block on which was placed a square base with a raised circular moulding for a column shaft (Fig. 4). Only one of these remains complete, probably because it was more deeply covered than any of the others by the fill in front of the Cathedral as seen in a photograph of 1892.⁴ A total of three blocks are identifiable on the south colonnade. The other pier bases exist as cement depressions for blocks. The easternmost one on the north colonnade retains the impression made by a projecting tenon from a reused block (Fig. 5). The others are recognizable because of the presence of foundations and because of restorations around cement pours. The identified bases correspond generally to each other north and south and on average are 2.6 m. apart on center, giving the present south colonnade a length of eight intercolumniations, the north ten.

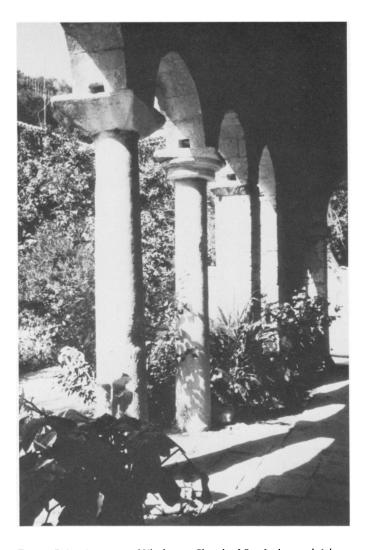
FIGURE 6. Monastery of Vlacherna, Church of Our Lady, porch (photo: Ann Zelle).

blocks, as at the 13th-century Frankish porch added to the Byzantine Church of Our Lady of the Monastery of Vlacherna, some three kilometers east of Kyllini (Fig. 6).¹⁰
